5R55W

Moaning Noise After Overhaul

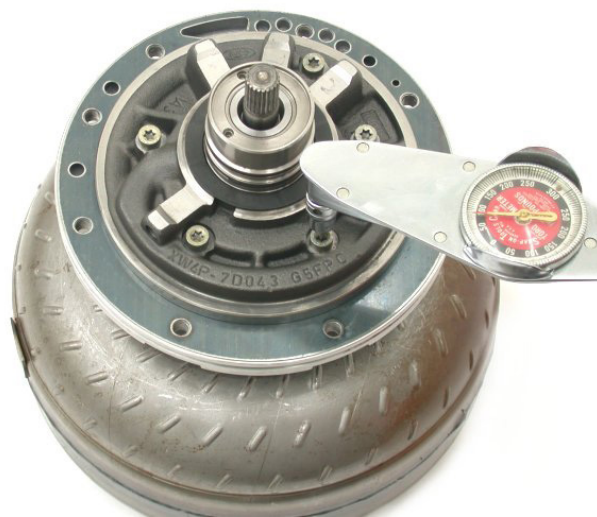
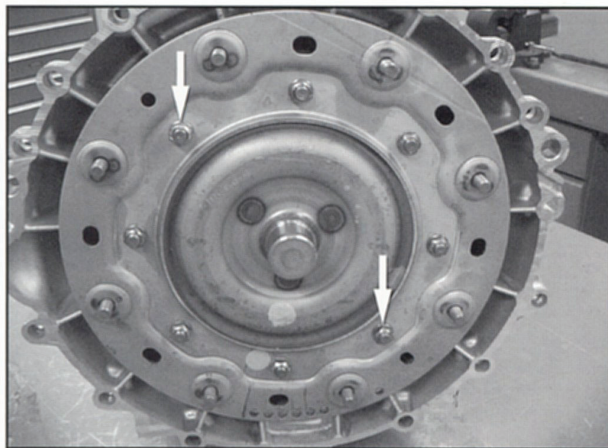
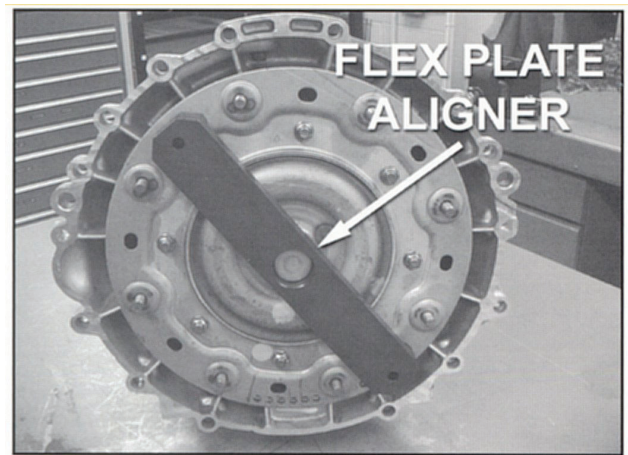
Severe to moderate moaning or humming noises from bellhousing area after overhaul could be caused by pump alignment. Sometimes this might be caused by the tool you're using. Make sure the tool is not damaged and verify its operation.

Note: Failure to properly align the pump may cause gear noise and premature pump bushing failure.

A tool must be used to align the pump halves before tightening the pump bolts. An A4LD alignment tool will NOT work for this job. If a tool is not available use the torque converter and the transmission input shaft. When the pump is properly aligned torque the pump bolts to 18 ft. lbs.
