## Technical Bulletin #1944

**Transmission:** 6DCT450, MPS6, 6DCT470

**Subject:** Repeat Mechatronic Failure

# 6DCT450, MPS6, 6DCT470 Repeat Mechatronic Failure

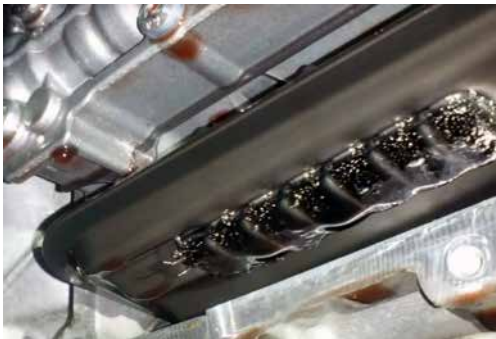
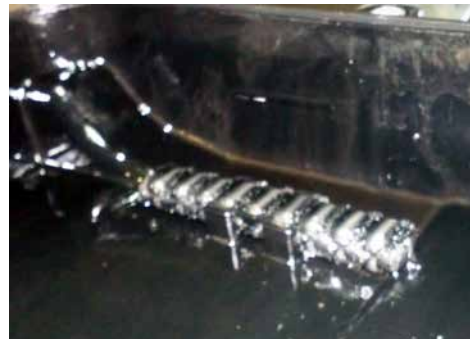
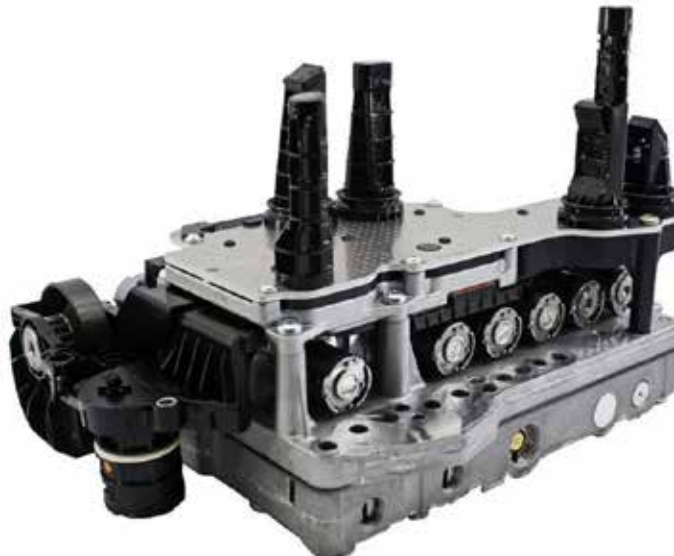
The control solenoids and control valves will become contaminated and will malfunction. The magnetic sensors will pick up loose, ferrous material in the fluid, causing the shift shaft position sensors and speed sensor signals to fail.

If the transmission fluid has excessive contamination, and the Mechatronic has been diagnosed to be faulty, the unit must be removed, disassembled and cleaned. This **MUST** be done even if there are no other concerns. Failure to do so will cause a repeat failure of the Mechatronic assembly!
