### **Transtar Tech Talk**

## **5R55N/S/W SERVO PISTONS**

The following addresses application and updates of the Overdrive/ Intermediate/ Low-Reverse Servo Pistons for 5R55N/S/W.

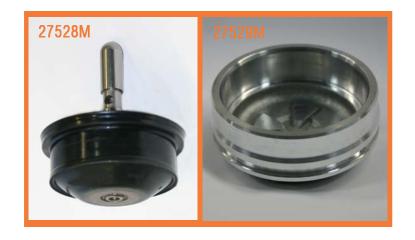
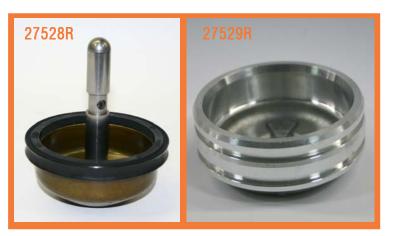
Release dia	Apply dia	0E #
5R55N/S	27528M	Tag #B	2.900	2.570	XW4Z-7D021KA (R/B 4W4Z)
	27528R	Tag #A	2.900	2.900	XW4Z-7D021LA (R/B 4W4Z)
5R55S/W	27528M	up to 3-02

5R55N/S/W
 27529M
 use with 27528M
 1 oring design
 XW4Z-7D027HB

27529R
 use with 27528R
 2 oring design
 XW4Z-7D027GB

**\*NOTE**: piston & cover must be used as a set (see illustration)

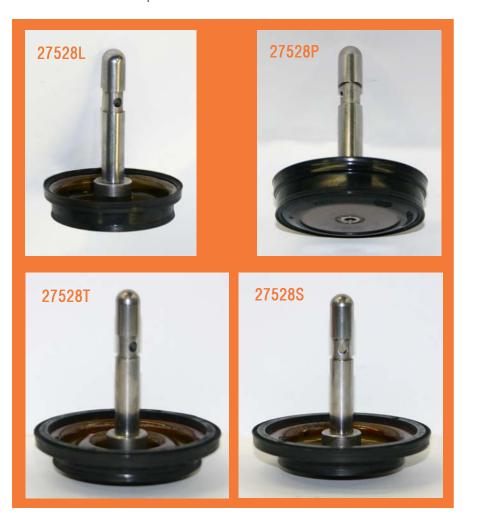
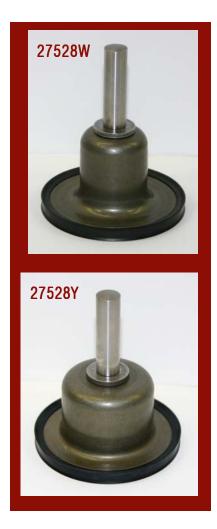
Servo rod bore wear has been prevalent on 5R55N/S/W models. Always check for bore wear & if found purchase the **T-9213** servo rod bore tool kit to repair the case.
